BMP Pilot Studies

Quarterly Status Report No. 5

BMP Pilot Projects in District 7 and District 11

CTSW-RT-99-085 June 15, 1999

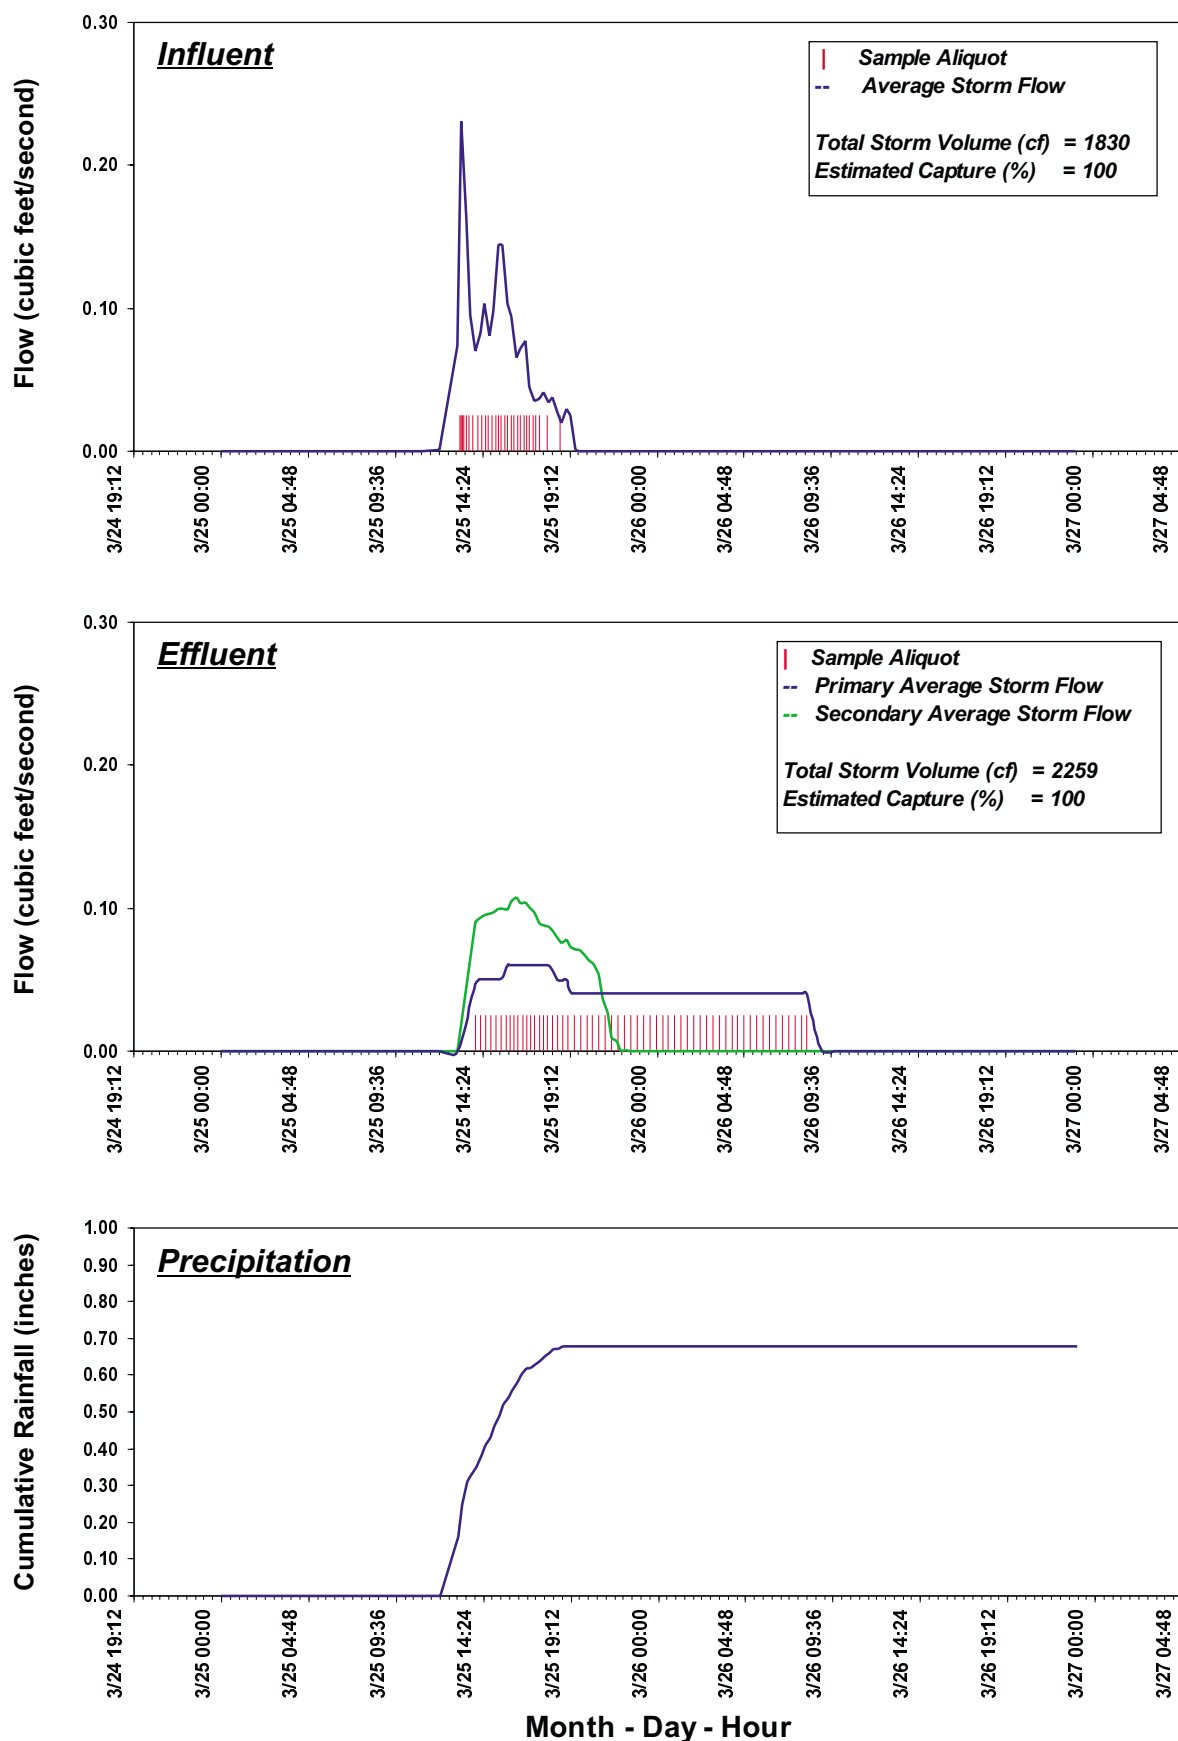
Figure 1.12. Average Flow and Cumulative Rainfall at State Route 78 and I5 Park and Ride for Event 3 (25-26 March 1999).

and reliable than the primary flow data which drove the flow proportioning. The secondary flow data is presented in this report. Data from both flow meters are presented in Figure 1.12 for the State Route 78 and I5 Park and Ride effluent to illustrate the magnitude of the flow proportioning problem that occurred at that site. The problem of locking stage values was corrected after the third event at all sites and was not observed anywhere during subsequent storm events.

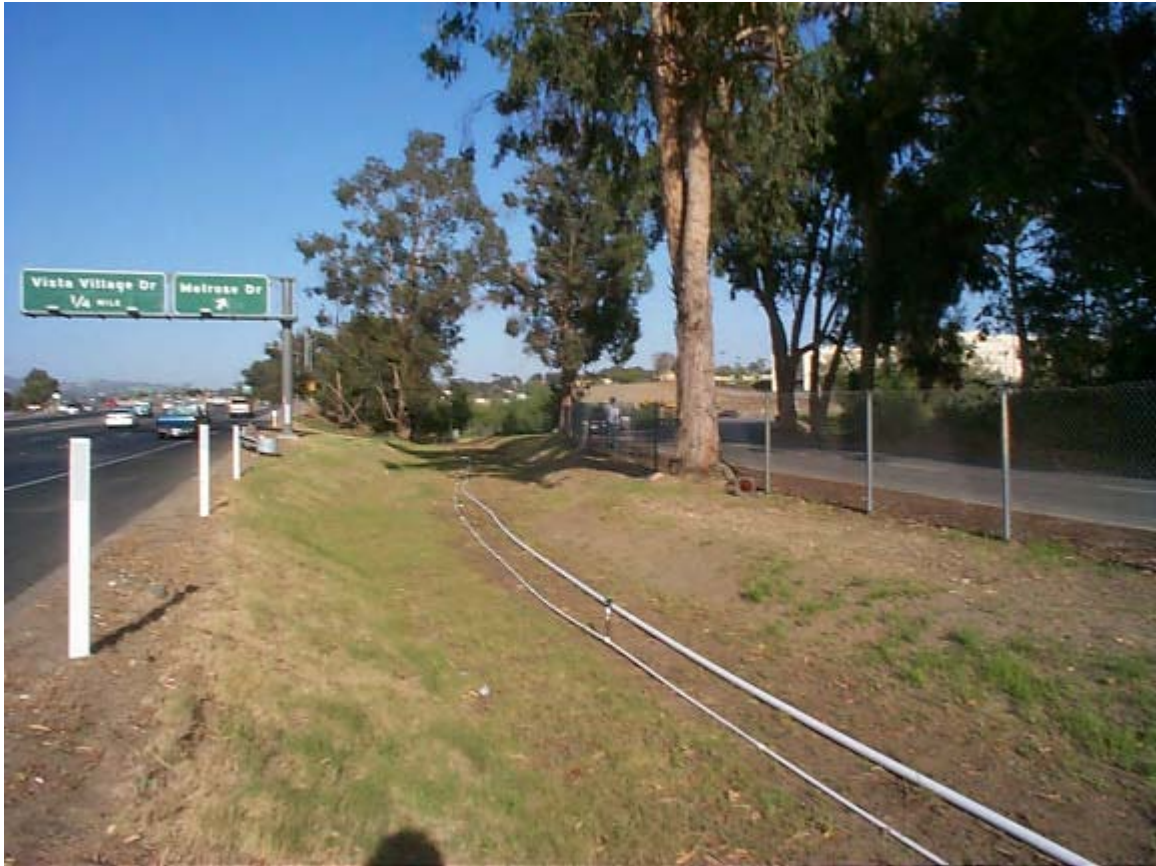
Melrose Drive Swale

Melrose Drive: Site is currently covered by approximately 70% saltgrass although much of the site remains in a 'dormant' state. This site is in good condition and we should expect full coverage with continued regular irrigation. Plugs of saltgrass will be taken from the side slope areas (above the active flow area) and placed in the invert to speed coverage.
